Re: Inspection of the Mitchell Municipal Solid Waste Landfill

**South Dakota Department of Environment and Natural Resources
Waste Management Program
Municipal Solid Waste Landfill Inspection Report**

Inspection photos from the Mitchell Landfill – May 18, 2016

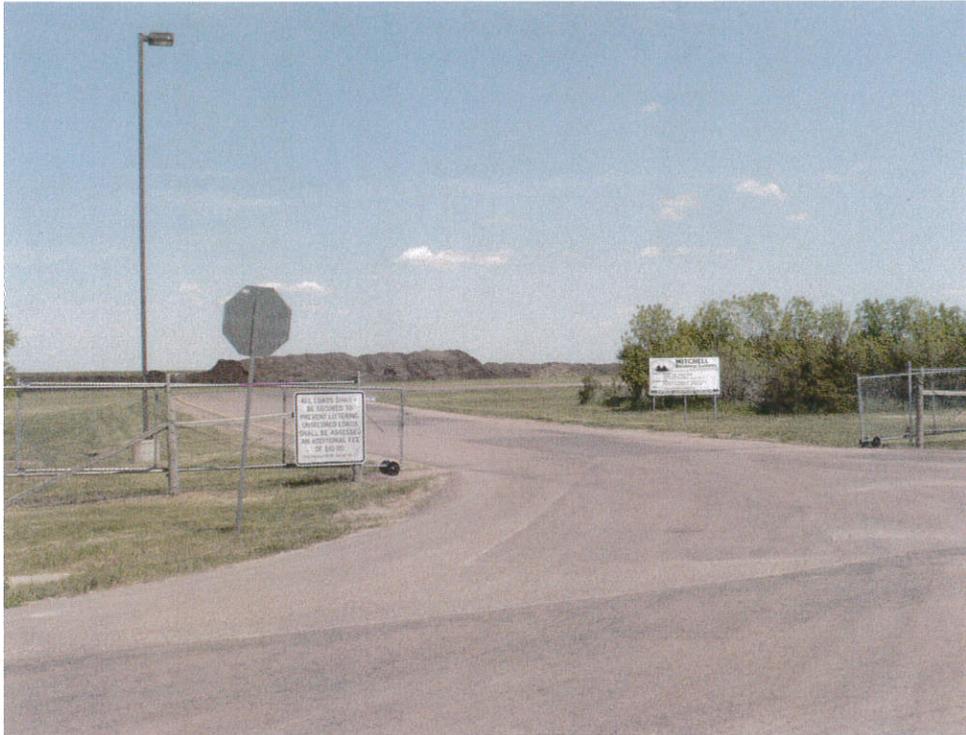
This photo shows the main gate leading to the landfill and some of the informational signs.

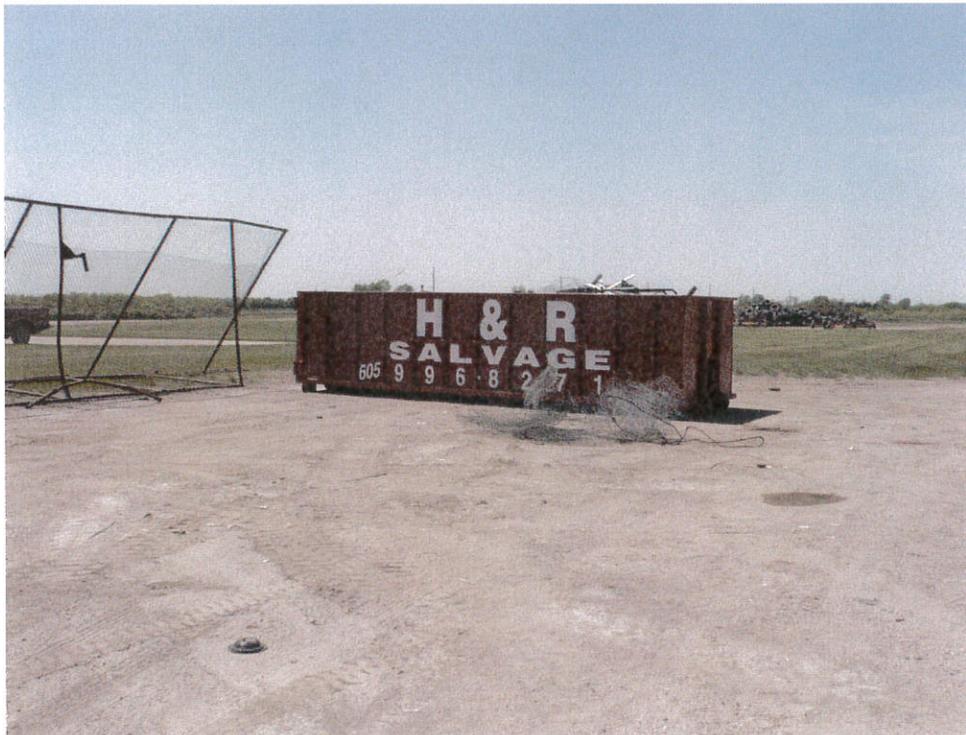
Photo showing the white goods and salvageable metal storage area located north of the scale house. H&R Salvage comes periodically to the site to pick up the white goods and metal for recycling.

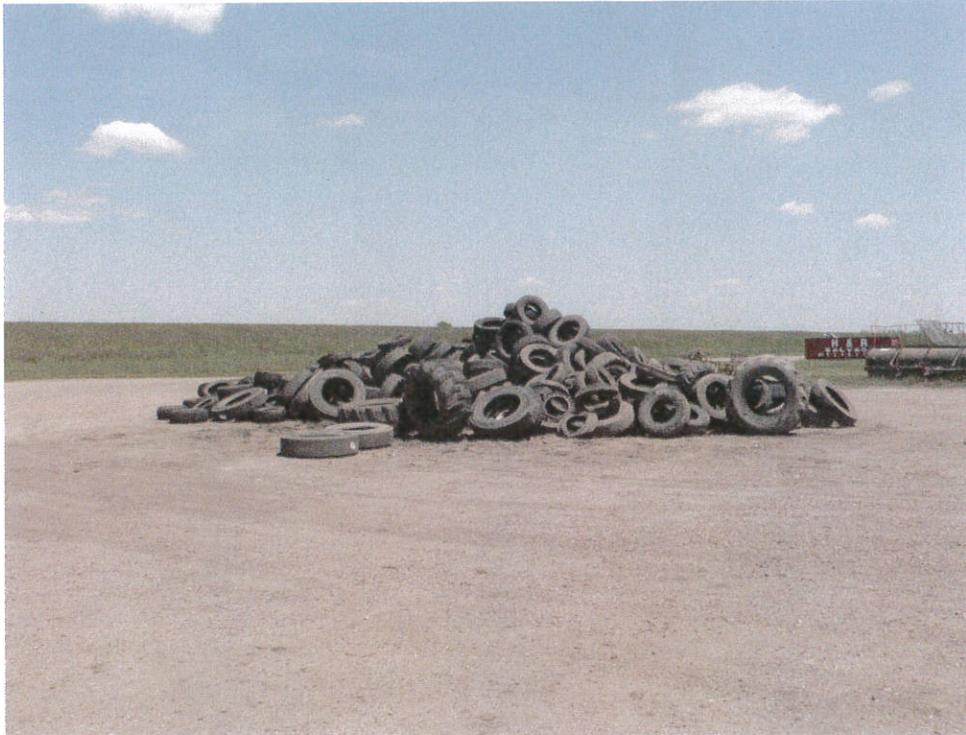
Photo of the waste tire stockpile area located west of the scale house. The operator has New Deal Tire, LLC come periodically to pick up the waste tires.

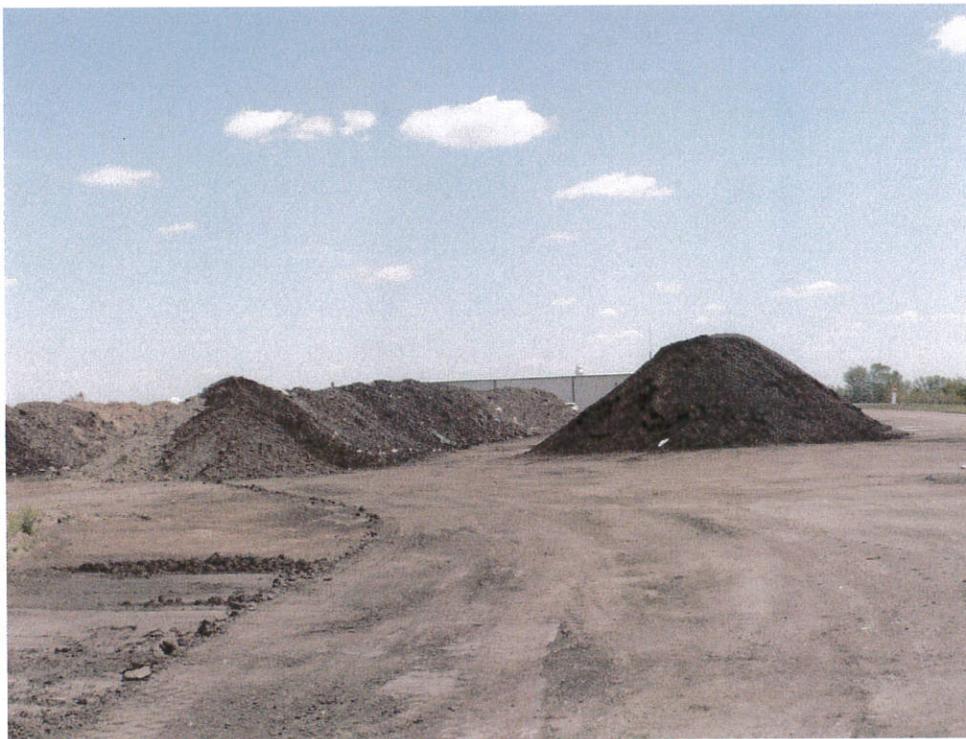
Photo showing some of the windrows of yard waste compost within the composting area. The dark pile of compost on the right is finished compost that's been screened and available to the public.

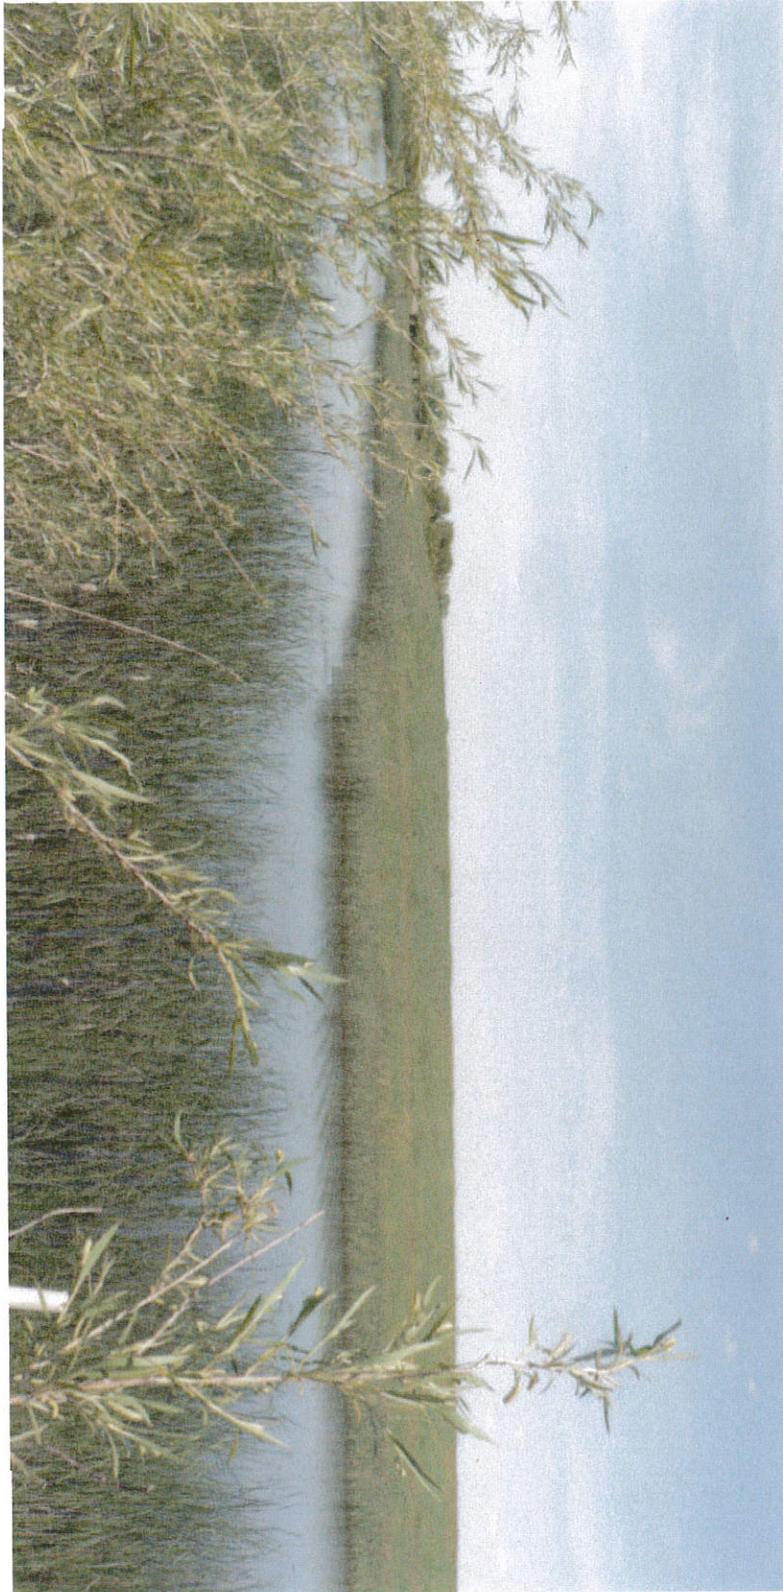
4. The landfill has been designed to divert normal surface water flow and storm water runoff away from the active fill area. Surface water is directed away from the MSW disposal area by perimeter ditches and storm sewer piping along with natural topography. Surface water is stored in a storm water pond located in the southwestern corner of the site. The landfill employees make periodic inspections of the water level in the storm water pond. The operator does have a storm water discharge permit for the storm water pond through the Surface Water Quality Program (SD00B408). The storm water pond has a culvert with a vertical slide gate so that the operator can manually drain the storm water pond into the constructed wetlands located south of the storm water pond. Tollefson stated that the landfill has not discharged any storm water from the pond since 2013. However with all of the recent rains the area has received, Tollefson said that the landfill will be discharging storm water from the pond to the wetlands in the near future.

This panoramic photo shows the landfill's storm water retention pond located in the southwestern portion of the site. The operator can discharge clean storm water to the constructed wetlands that are located south of the pond.

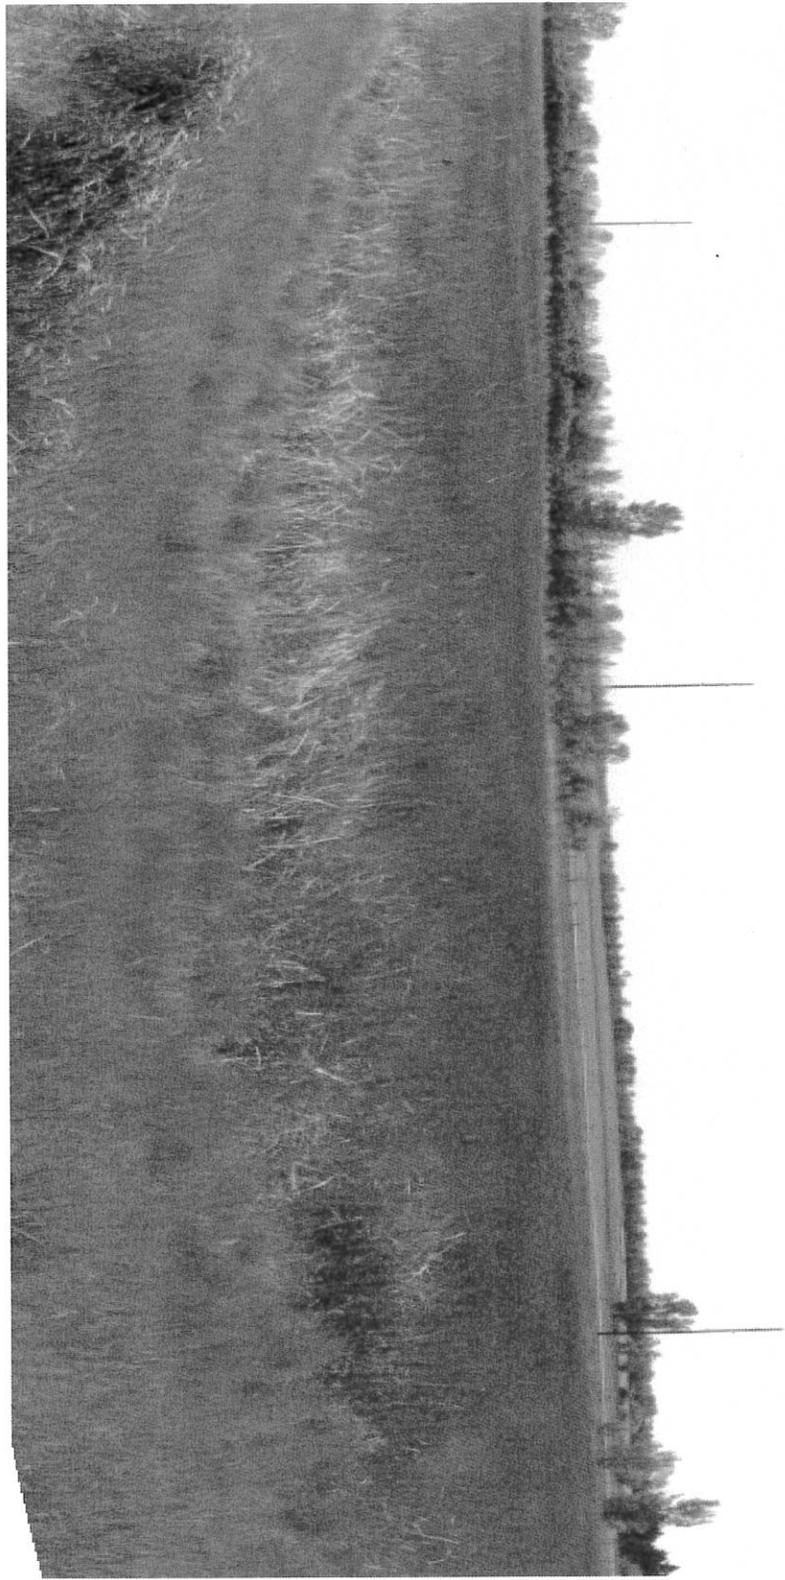
Panoramic photo of the constructed wetlands located south of the storm water pond.

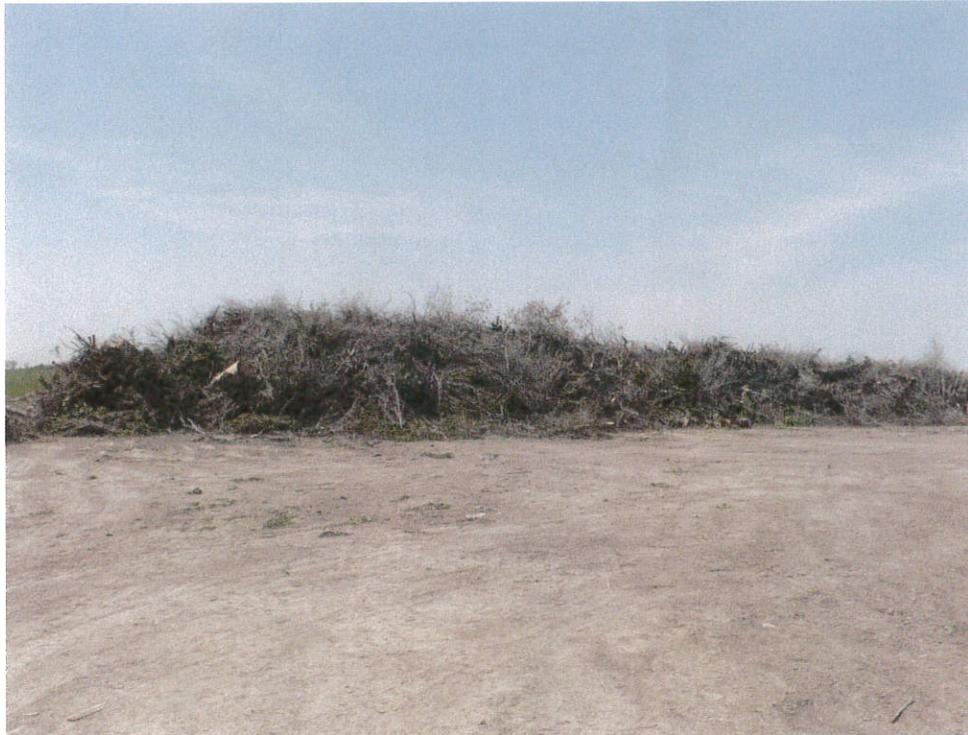
5. In the past, the operator burned trees, tree branches, and untreated wood as needed. The operator now stockpiles the clean wood waste south of Cell #2. There's one large pile of trees and branches and another large pile of pallets and untreated wood. The operator has an agreement with Mueller Pallet to have them come to the landfill and grind the clean wood waste for recycling/reuse. Last year, the landfill accepted 2,610 tons of clean wood waste. Oversized tree trunks that cannot be ground are hauled to the Mitchell restricted use facility for disposal.

This photo shows the landfill's tree and tree branch pile located south of the lined disposal area. The operator has a separate pile for untreated wood. The landfill has Mueller Pallet come periodically to grind the clean wood waste for recycling.

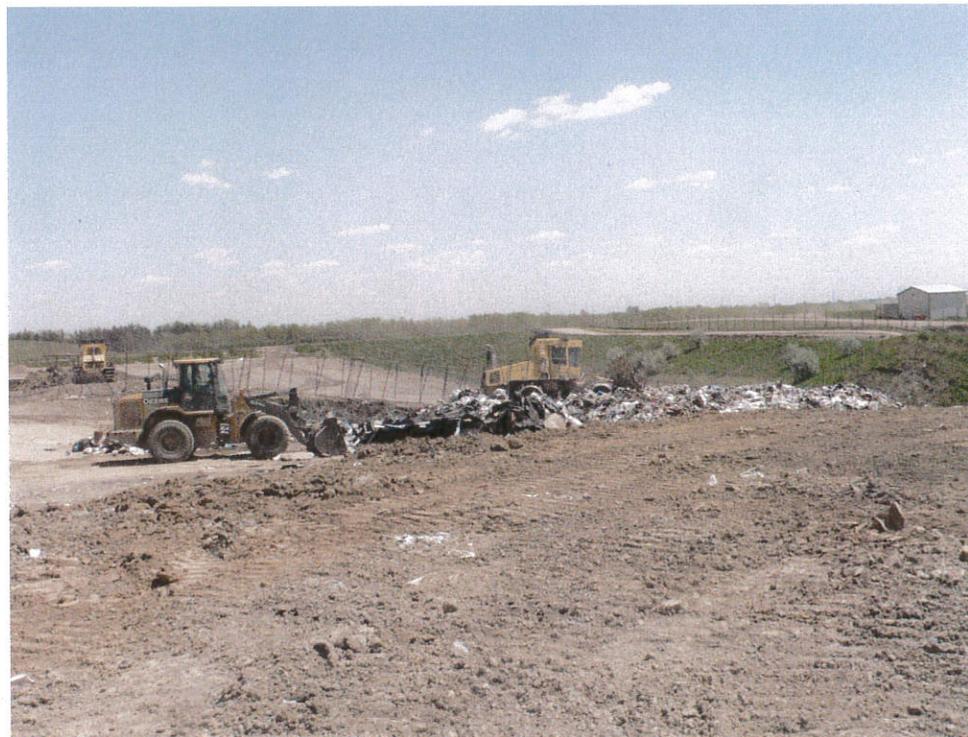
2. Tollefson said that the landfill staff typically tries to maintain a working face that's 50 feet wide by 100 feet long. The operator spreads the waste in lifts that are no more than two feet in thickness. The compactor operator makes a minimum of three to five passes over the waste to ensure the waste is sufficiently compacted. Tollefson said that the landfill compactor has a Global Positioning System (GPS) installed in it. The GPS system is designed to help the compactor operator determine when the MSW is adequately compacted.

This photo shows the landfill staff spreading and compacting waste within the lined disposal area. The portable litter fences were placed downwind of the working face to help contain litter.

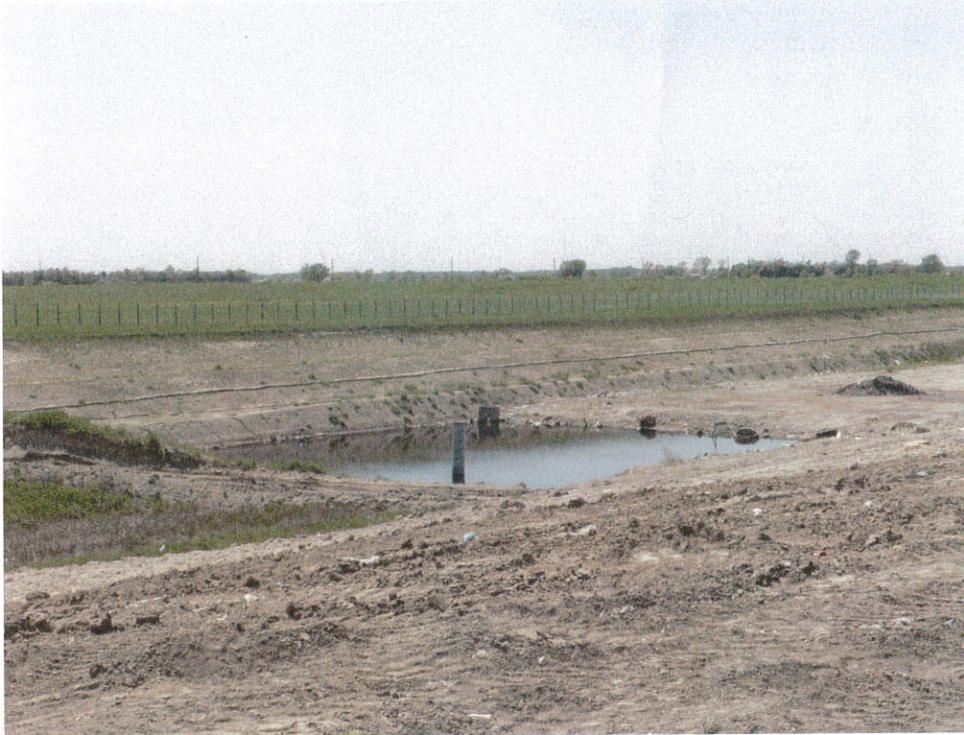
12. Leachate from the lined MSW disposal is collected in a subsurface collection system which pipes the leachate to the Mitchell wastewater treatment facility for disposal. The treatment facility is adjacent to the landfill on the north side of the permitted boundary of the landfill. During the first four months of this year, the landfill has sent 1,096,000 gallons of leachate to the Mitchell wastewater treatment facility. The operator has the leachate tested twice per year as part of the landfill's monitoring plan. In addition, the wastewater treatment facility tests the landfill leachate twice per year. It was noted that there was an area (approximately 80 ft. by 100 ft.) in the southeastern corner of Cell #3 where there was standing fluid in the cell. The area is just south of where the leachate collection piping from Cell #3 ties into main north-south leachate collection line. It is in the lowest area of Cell #3. Tollefson said this area was the only area of Cell #3 that hasn't had any MSW placed. Based on this information and the design of Cell #3, the standing fluid observed is a mixture of leachate collected from the upslope area of Cell #3 and storm water runoff from the soil covered areas of Cell #3 and the south facing slope of Cell #2. He said that the leachate pumping system has been pumping leachate out of the cells at a rate of 105-110 gpm. I encouraged Tollefson to take additional measures to get the standing leachate pumped out of the cell as soon as possible.

This photo shows the SE corner of Cell #3 where there was standing leachate on the liner. The operator was encouraged to get the leachate pumped out as soon as possible.

1. The operator will need to ensure that adequate financial assurance funds are set aside at the end of 2016 to cover the accrued liability accumulated this year.
2. The operator needs to take additional measures to get the standing leachate pumped out of Cell #3 as soon as possible.

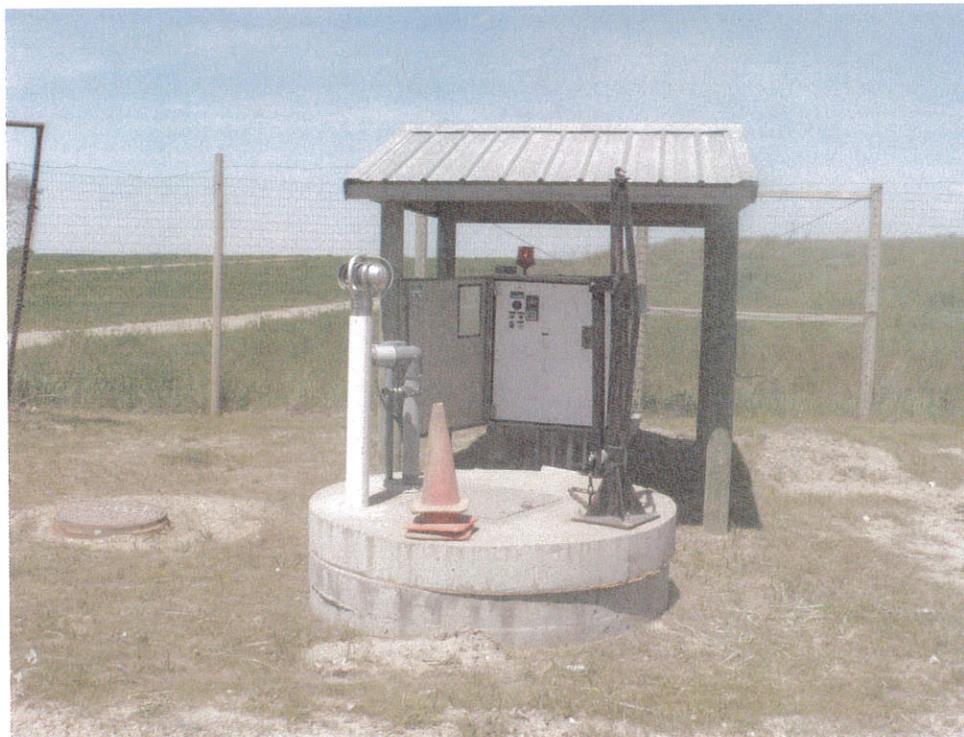
Photo showing the leachate manhole and control system located north of the lined disposal area.
